IDWAL

CONDITION
REPORT

EXAMPLE GENERAL CARGO

INSPECTED AT CAPE TOWN SOUTH AFRICA
01st OCTOBER 2022

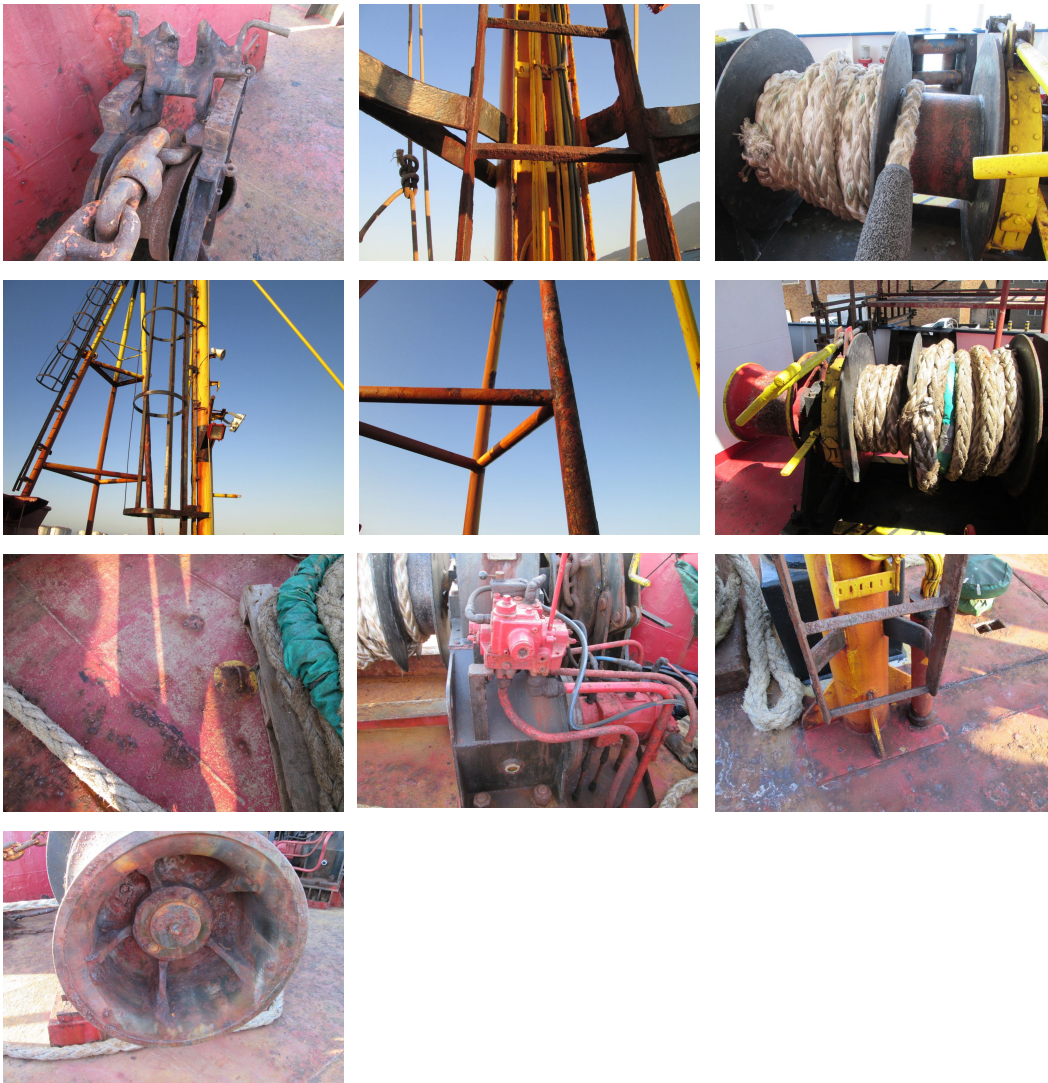
Issue: The foc'sle was seen with widespread established corrosion, covering approximately 10% of the mooring deck plating total surface area. Deck fittings were found to be in a fair condition with the majority of fittings such as rollers and bits seen with established corrosion.

Corrective Action: Areas of Coating breakdown and corrosion should be addressed when possible.

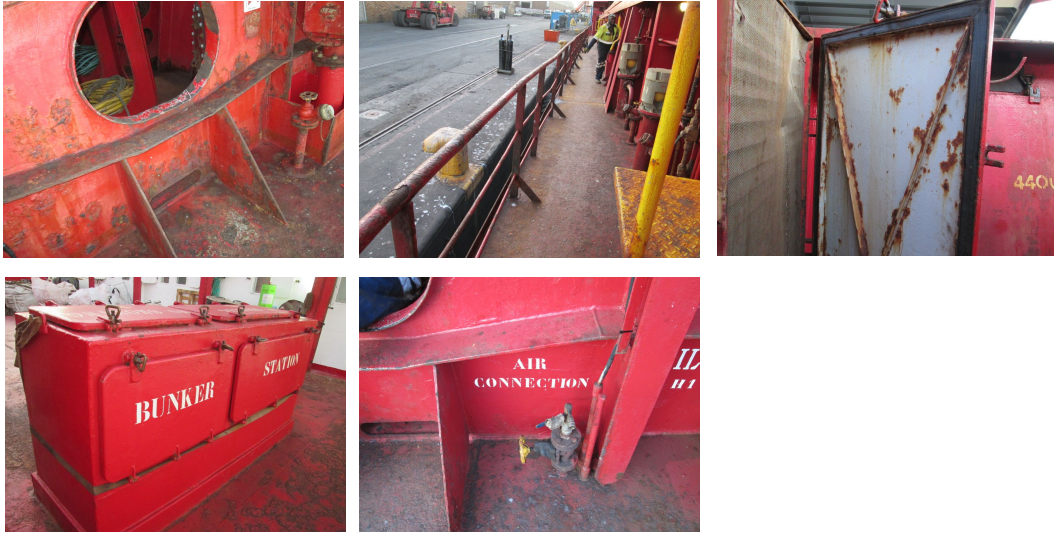
Description	Estimated Cost [USD]
<p>Issue: The main deck had moderate localised corrosion, up to approximately 10% of the main deck plating total surface area, mainly located on walkways. Deck fittings were found to be in a fair condition due to the majority of fittings such as ventilation louvers and railings being seen with widespread corrosion.</p> <p>Corrective Action: Areas of Coating Breakdown and Corrosion should be addressed when possible.</p>	\$5000 - \$20000

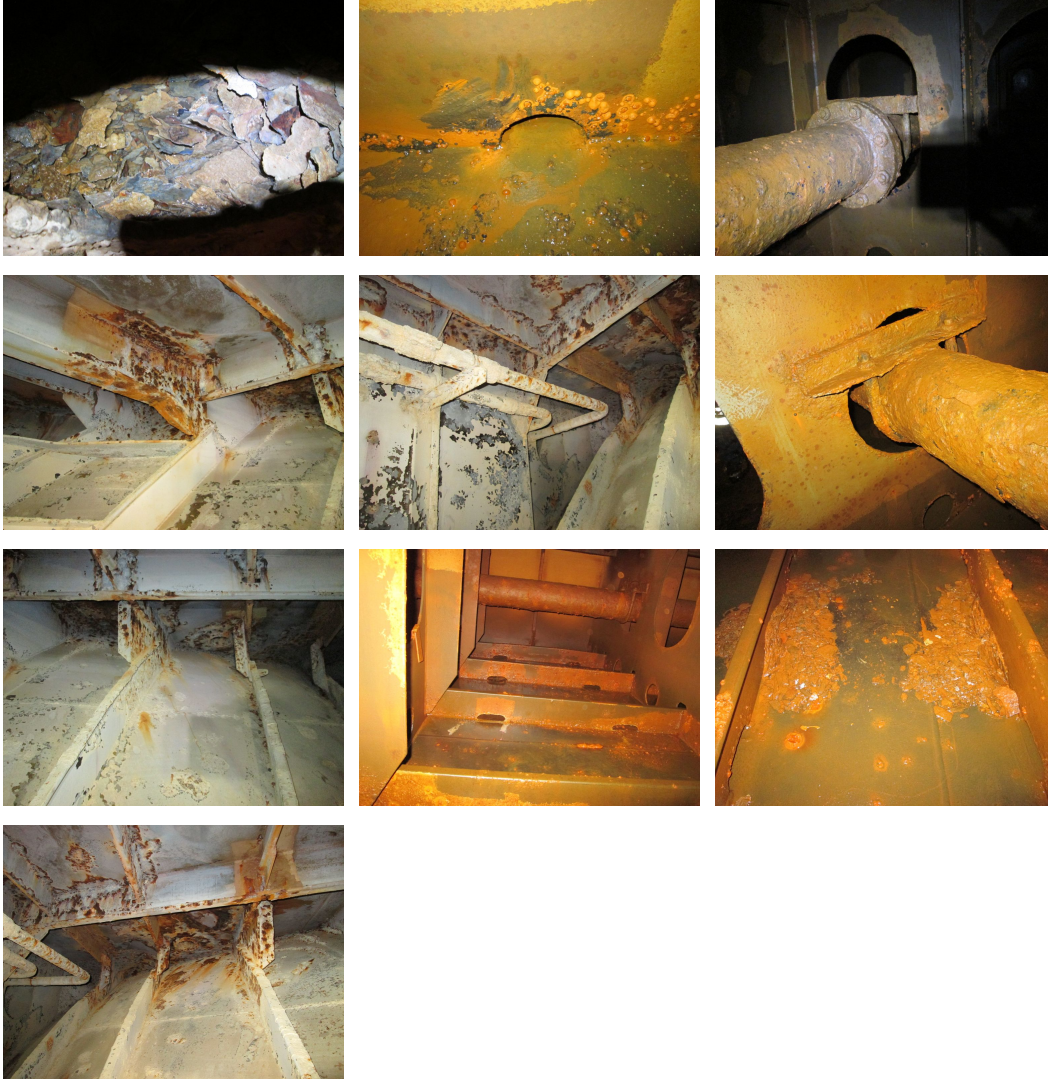
<p>Issue: Corrosion was seen to be widespread throughout the ballast tanks with scaling debris seen in the tanks.</p> <p>Corrective Action: Areas of Coating Breakdown and Corrosion should be addressed when possible.</p>	\$50000+

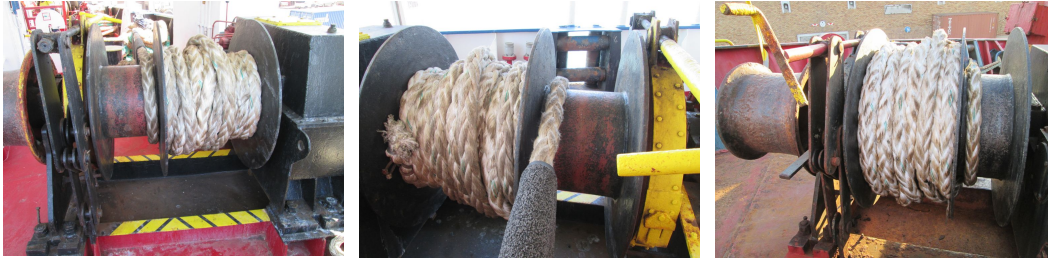
Description	Estimated Cost [USD]
<p>Issue: Mooring practices were seen to be poor, with insufficient turns taken on split drums and bits and ropes arranged in a manor that may cause abrasion damage.</p> <p>Corrective Action: Mooring procedures should be reviewed in line with industry best practice.</p>	<\$1000
