CONDITION  
REPORT

# EXAMPLE LPG CARRIER

IMO Number: 123456789

INSPECTED AT NIGERIA  
1<sup>st</sup> OCTOBER 2022

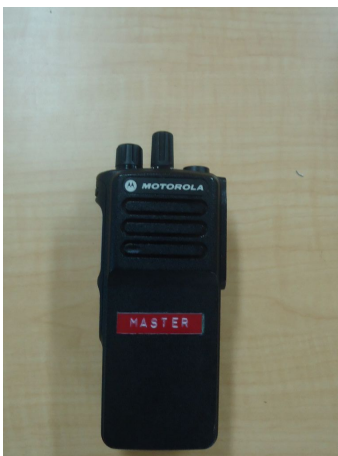
**Issue:** One portable UHF radio was seen to be missing the antenna, potentially reducing its range.

**Corrective Action:** Ensure radio equipment is correctly maintained.
