CONDITION  
REPORT

## EXAMPLE VESSEL

IMO Number: 123456789

INSPECTED AT EXAMPLE PORT  
MALAYSIA

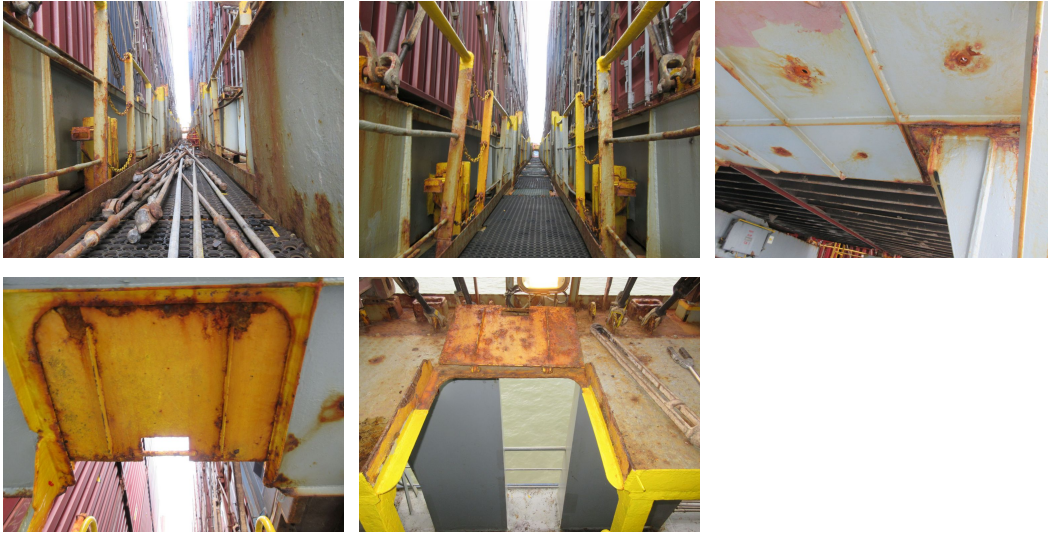
Description	Estimated Cost [USD]
<p><b>Issue:</b> Lashing platforms were seen with instances of spot corrosion particularly on hand rails.</p> <p><b>Corrective Action:</b> Areas of coating breakdown and corrosion should be addressed when possible.</p>	<\$1000
