## PRE-SALE REPORT

# EXAMPLE VESSEL

IMO Number: 123456789

INSPECTED AT VIETNAM  
1st OCTOBER 2022

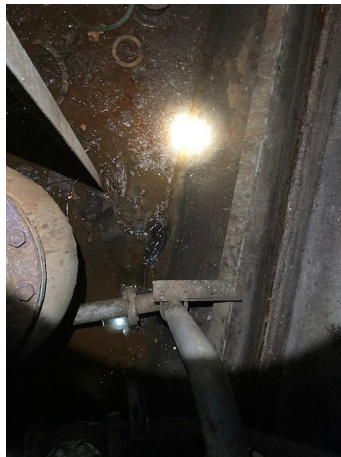
**Issue:** Purifier and aux generators noted with areas of oil accumulation and staining.**Corrective Action:** To be cleaned and maintained properly
