PRE-PURCHASE  
INSPECTION

# EXAMPLE BULK CARRIER

IMO Number: 123456789

INSPECTED AT EXAMPLE PORT, TURKEY

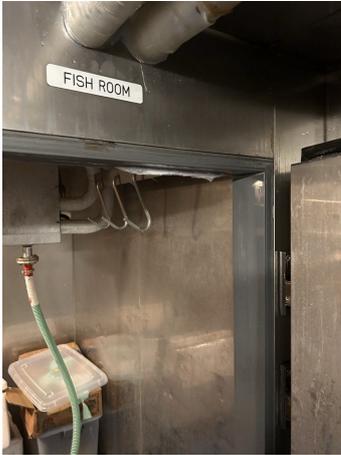
| Description | Estimated Cost [USD] |
|--|---|
| <p><b>Issue:</b> Provisions equipment was seen with excess frosting with minor ice accumulation noted on the upper corner of fish room inner door frame, as well as to sections of the external pipework.</p> <p><b>Corrective Action:</b> De-frost and rectify root cause of excess ice build-up.</p> | <\$1000 |

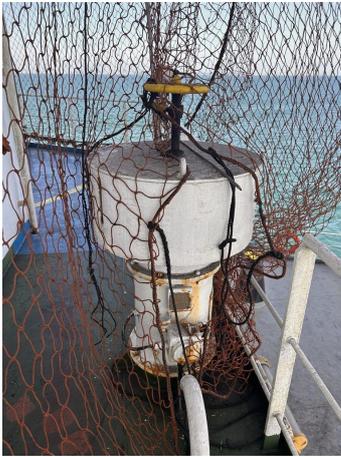
**Issue:** The paint store fan damper was seen to be covered with nets that obstructed the access and operation, as well as missing open/close markings sighted on the ventilation dampers on poop deck.

**Corrective Action:** To be further investigated and rectified as soon as practical.

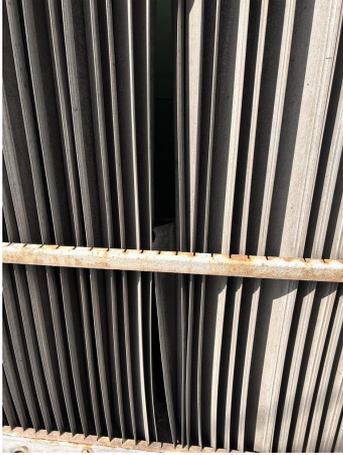
**Issue:** Several ventilation louvers of engine room port and starboard side fans were found to be broken.

**Corrective Action:** To be further investigated and rectified as required.
