PRE-PURCHASE
INSPECTION

EXAMPLE GENERAL CARGO

IMO Number: 123456789

INSPECTED AT EXAMPLE PORT UNITED STATES
1st OCTOBER 2022

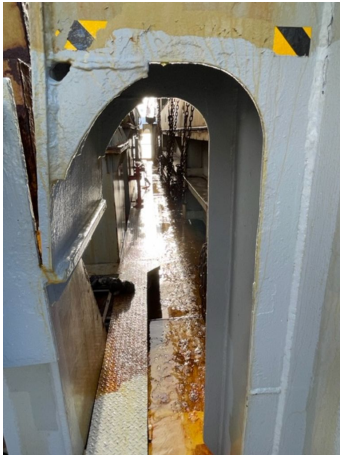
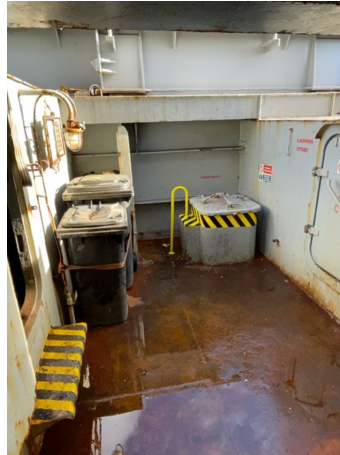
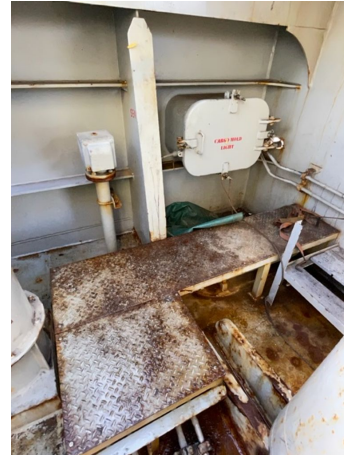
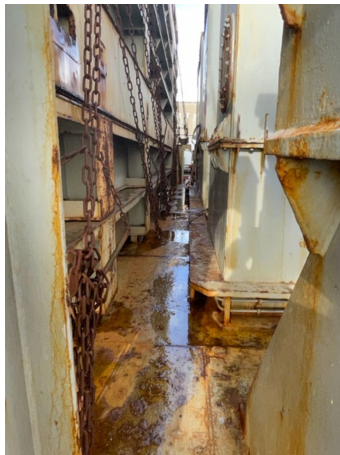
The Weather Decks and Fittings were seen to be in a fair to good condition overall, with the decks found to be free of structural defects. Walkways were seen to be free of significant corrosion with some spot corrosion seen near railings. Cross decks were seen to be used for storage, however the visible areas were seen with widespread corrosion and resultant staining. Deck fittings

Issue: Cross decks were seen to be used for storage, however the visible areas were seen with widespread corrosion and resultant staining.	\$1000 -
	Corrective Action: Areas of coating breakdown and corrosion should be addressed when possible.	\$5000

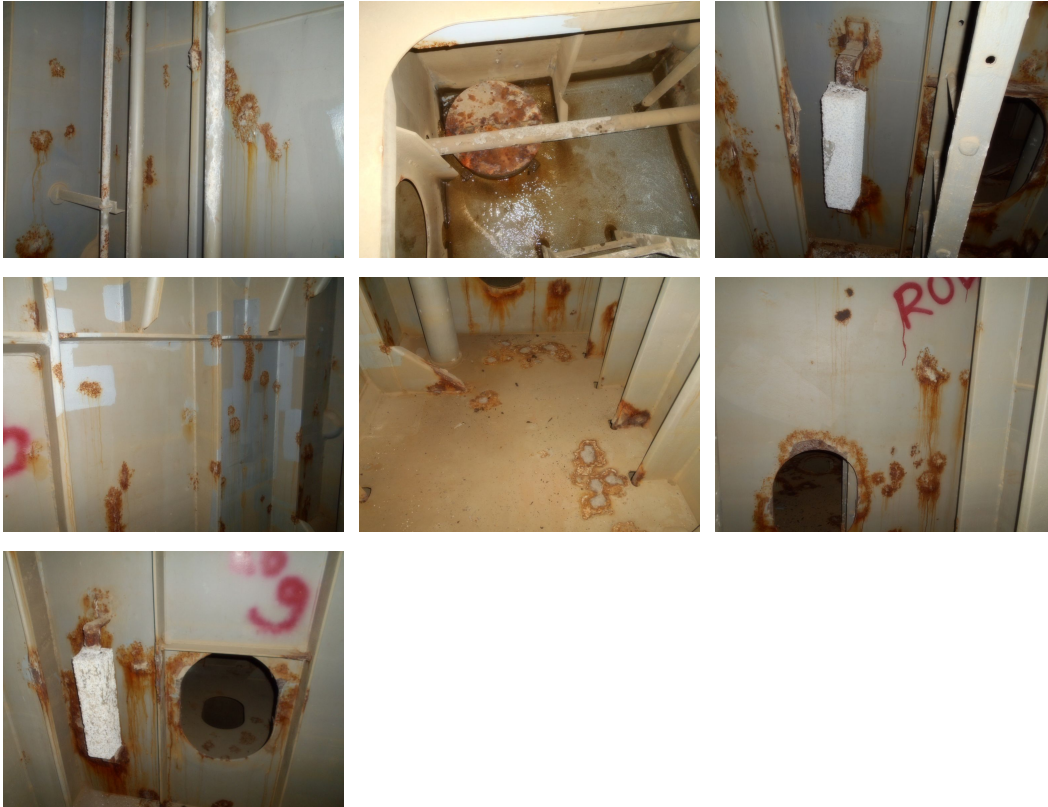
Ballast tanks and systems were deemed to be in a good overall condition. No tanks could be for operational reasons, however, photographs of previous tank entries in 29-Oct-22 were provided for review. From the photographs provided, it was seen that the ballast tanks were generally free of significant structural defects and had only minor scattered corrosion, up to approximately 5% of the ballast tanks total surface area, mainly located near

Issue: Ballast tanks were seen with areas of scattered corrosion.

Corrective Action: Areas of coating breakdown and corrosion should be addressed when possible. \$1000 - \$5000

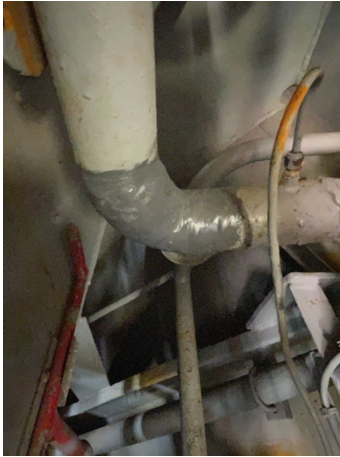
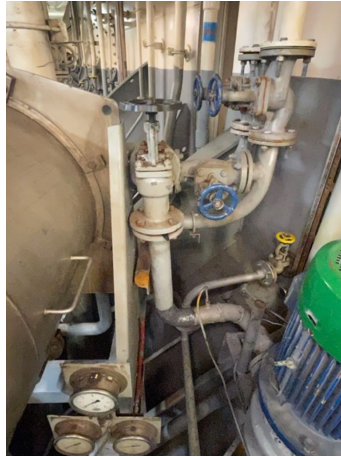
Issue: Temporary repairs were seen on the fresh water generator sea water pipe.

sea water line to the fresh water tank was seen with temporary repairs

Corrective Action: Renew areas of pipework that have temporary repairs.

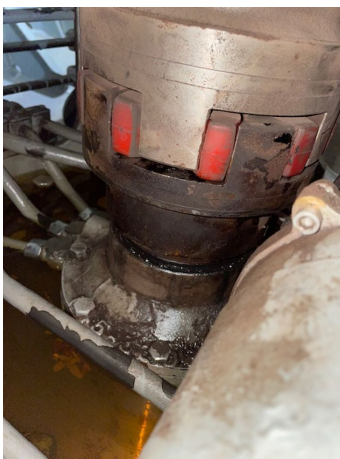
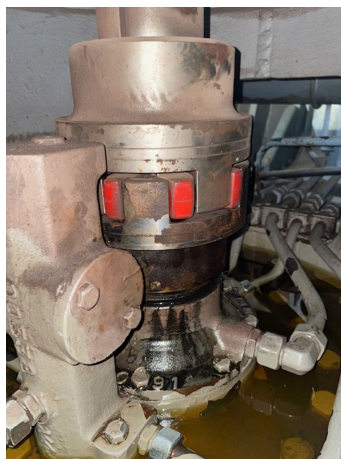
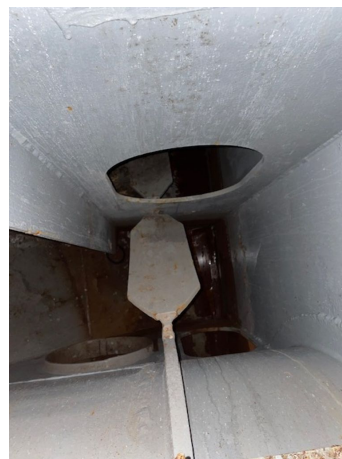
Issue: Bow thruster seen with leaks.

seen with a leak

Corrective Action: Overhaul thrusters as soon as possible.

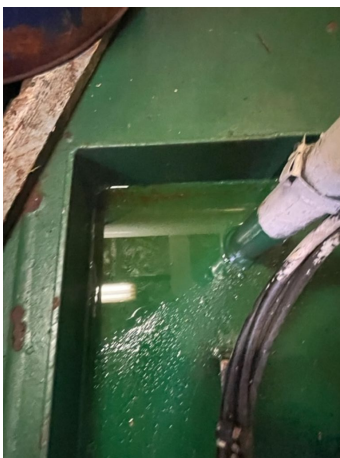
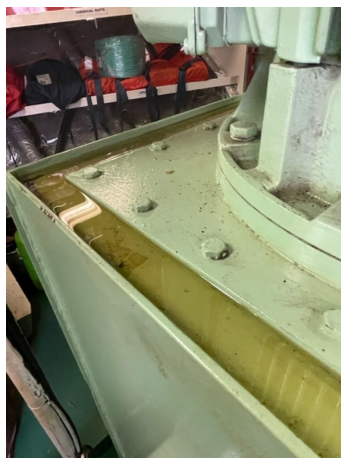
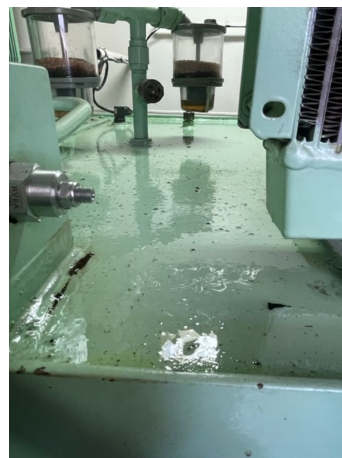
Issue: The Hydraulic pump unit for the hatches was seen with leaks.

Corrective Action: To be rectified as soon as practical.

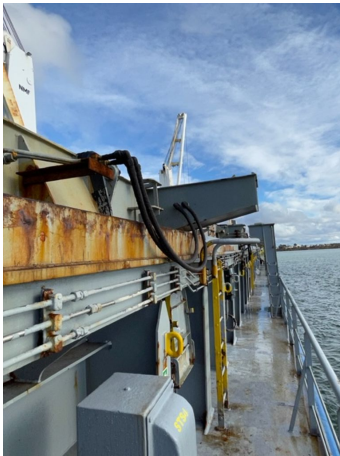
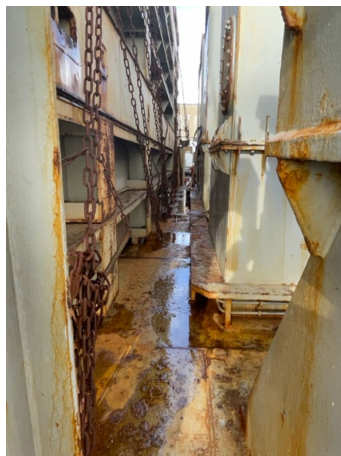
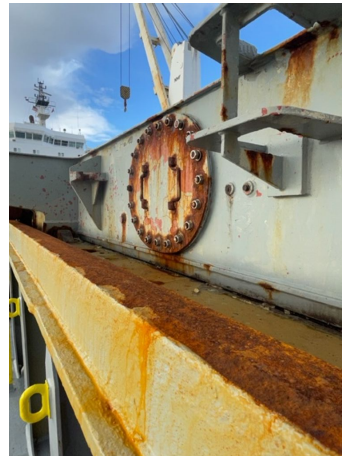
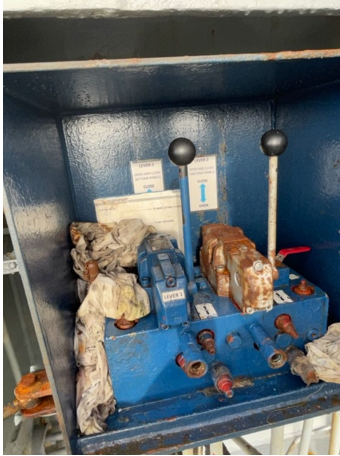
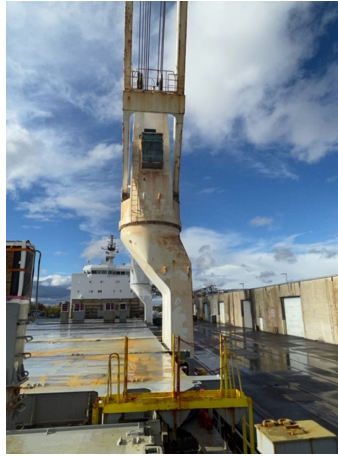
Issue: External areas of the cargo systems such as hatch covers and cranes, including fittings such as control boxes were seen with developing corrosion, up to approximately 5% of the hatch cover surface area, mainly located near edges.

Corrective Action: Areas of coating breakdown and corrosion should be addressed when possible.
