CONDITION  
REPORT

# EXAMPLE VESSEL

IMO Number: 123456789

INSPECTED AT EXAMPLE PORT, SOUTH  
AFRICA 1<sup>st</sup> MAY 2023

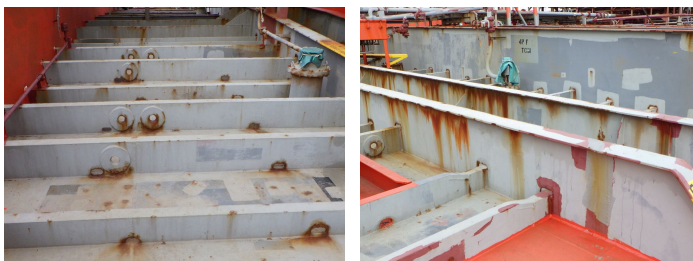
**Issue:** Areas of the main deck and fittings were seen with instances of developing corrosion. Some areas of general coating deterioration (peeling) were seen on walkways.

**Corrective Action:** Remedial cosmetic maintenance should be carried out in the affected areas as soon as practical.
