## **EXAMPLE TANKER**

IMO Number: 123456789

INSPECTED AT YOKKAICHI JAPAN

01<sup>st</sup> OCTOBER 2022

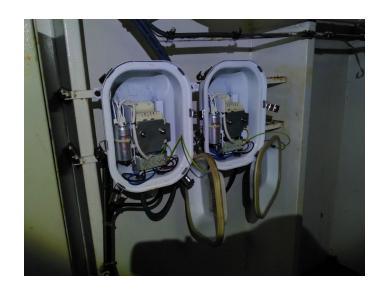
Description	Estimated Cost [USD]
<b>Issue:</b> Two electrical connection boxes inside the forecastle store were seen to have damaged covers.	
<b>Corrective Action:</b> To be further investigated and rectified as soon as practical.	<\$1000

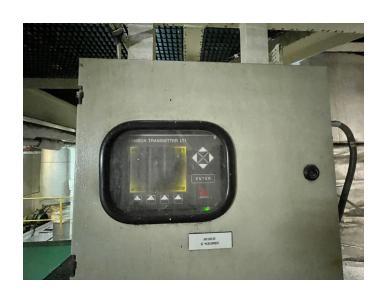
Description	Estimated Cost [USD]
<b>Issue:</b> The auxiliary boiler O2 measurement panel was noted to be faulty.	
Corrective Action To be further investigated and restified as seen as practical	\$1000 - \$5000

**Corrective Action:** To be further investigated and rectified as soon as practical.

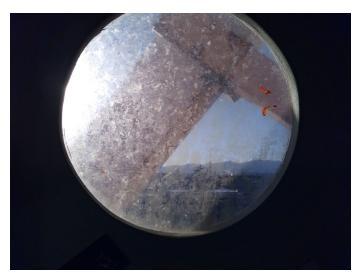
Lifesaving appliances were seen to be in a fair to good overall condition, primarily due to obscured lifeboat window and the illegible rescue boat magnetic compass, though all equipment was reported to be regularly serviced and inspected as required. The vessel is fitted with 1 free-fall lifeboat, which was seen to be in good overall condition externally though was in fair condition internally with the perspex for the window was seen to be heavily obscured. The lifeboat engine(s) was not tested during the inspection, but was reported to be in good working order. The vessel's rescue boat was found to be in a fair overall condition with the magnetic compass fitted seen to be unreadable. The vessel is equipped with 5 life rafts, which were found to be in good condition with Hydrostatic Release Units (HRUs) in date and correctly rigged. Davits and lowering arrangements were found to be in good condition overall with evidence of regular maintenance, servicing and inspection sighted and evident. Ancillary lifesaving equipment such as lifejackets, immersion suits and EEBD's etc. were found to be in good condition and ready for immediate use with man overboard smoke and light signals seen to be in date. Embarkation ladders were found to be in a good, well maintained condition with the pyrotechnics and line throwing apparatus found to be stored appropriately and within their expiry dates.

Corrective Action: To be further investigated and rectified as soon as practical.

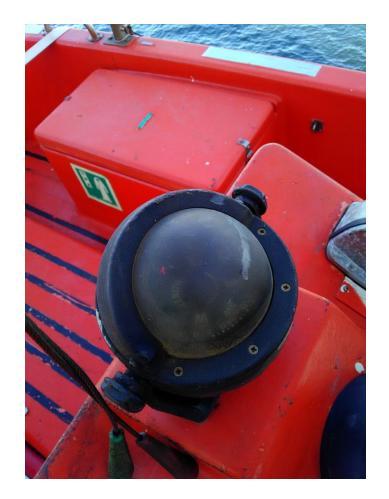
Description	Estimated Cost [USD]
<b>Issue:</b> The magnetic compass fitted to the rescue boat was seen to be unreadable.	<\$1000
<b>Corrective Action:</b> To be further investigated and rectified as soon as practical.	<\$1000
