# IDWAL

## TECHNICAL GUIDE

Accommodation

Idwal 2022

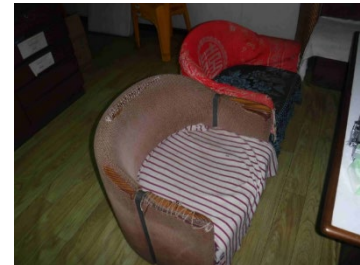
*Temporarily repaired chairs*

Similar to the wall and floor coverings this should be a general oversight with defects noted specifically, e.g. "recreation room seating was seen to have tears to arm rests and with various broken legs which had been temporarily repaired". Attention should be paid to the quantity of items as well as the quality, e.g. are there sufficient dining room chairs?

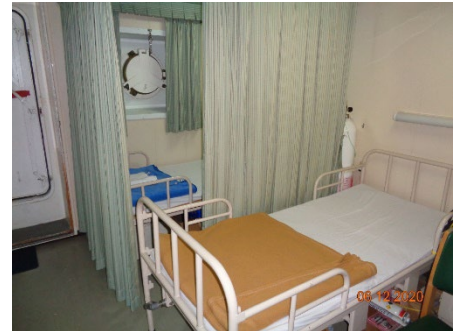
*Neat and well-equipped Hospital*

The hospital should be clean and organised with all equipment ready for use. The bed should be made with Resuscitator nearby. The bathroom and shower should be clean and accessible. There should be no indication that the hospital is being used as a store room or additional cabin.

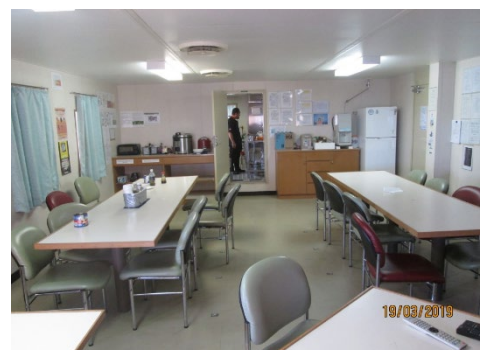
An average standard of outfitting is seen. Cabins should have sofas, desks and wardrobes. Pictured: A mess room typical of a modern standard panamax bulk carrier.

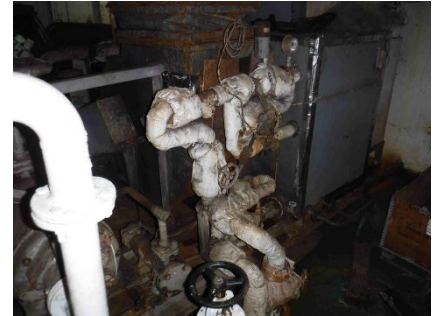
*Poorly maintained and corroded Air Handling Unit (AHU)*

Visually inspect the AHU and look for leaks, corrosion, condition of lagging and pipework. Refrigeration equipment for the AHU should be in good visual condition, free of leaks and corrosion. Refrigerant bottles should not be permanently connected to the system and should be stored in approved locations and racks.

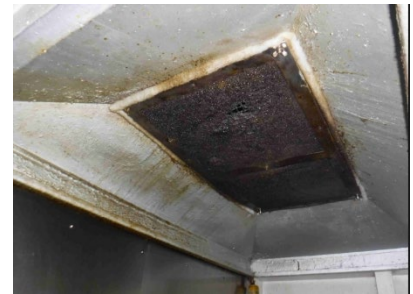
*Build-up of grease creating a potential fire hazard*

Inspect the galley hoods and extraction covers for signs of regular cleaning or neglect. Any build-up of grease or fatty deposits can be a fire hazard which should be reported and accompanied by a relevant photograph.

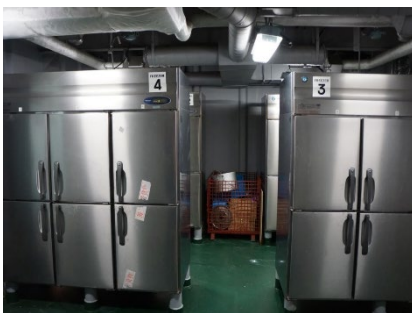
*Standalone freezer stores, commonly vessels fitted with these freezers also have a walk in fridge room.*

What is the primary method of cold storage? Does the vessel have 'standalone' domestic style freezers such as under counter or chest freezers or is the vessel equipped with walk-in stores and cold rooms that are likely serviced from a centralised refrigeration plant?

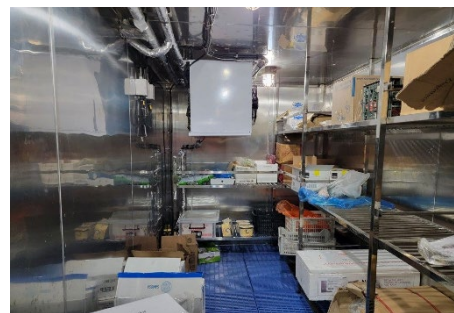
*Walk in cold room, note the blue matting to keep food off the deck.*

Ensure to inspect all store rooms and comment on whether they appear to be well kept with provisions arranged in a meaningful manner i.e. stacked neatly, in rows, in boxes, rotated by expiration date etc. Note, the use of pallets is often utilised to avoid storing provisions directly on deck but it should be made from a non-absorbent material and not wood. Please also include a photograph of each store.

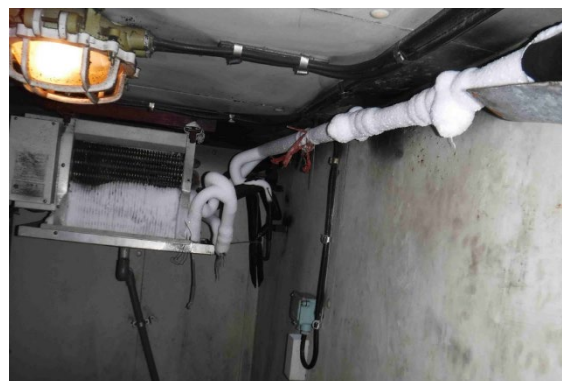
*Excessive ice accumulation to pipework and evaporator*

Inspect as many of these areas as possible. Common places of excessive ice build up are often expansion valves (a small amount is to be expected), poorly insulated sections of pipework, ineffective door seals and evaporators located in the cold rooms themselves.

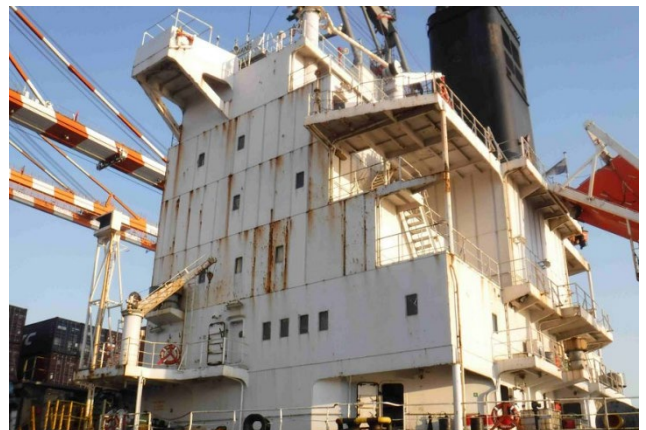
*Up to approximately 5% scattered corrosion, mainly at weld seams with subsequent corrosion staining*

Common areas of coating breakdown may be at openings such as portholes and at weld seams. Consideration should be given to the difficulty in maintaining these areas as well as the actual amount of corrosion and how much is just subsequent corrosion staining.
