IDWAL

CONDITION
REPORT

EXAMPLE GENERAL CARGO

INSPECTED AT CAPE TOWN SOUTH AFRICA
01st OCTOBER 2022

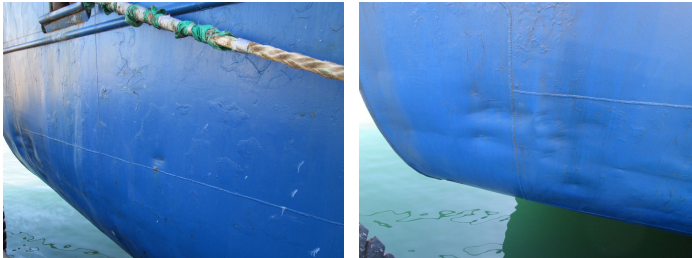
The hull was seen to be in a fair to good overall condition, with the hull able to be inspected from the starboard side only. The vessel was found to be free of major structural defects, however, shallow indents were seen on the stern area. Coatings were seen with minor

Corrective Action: For information.

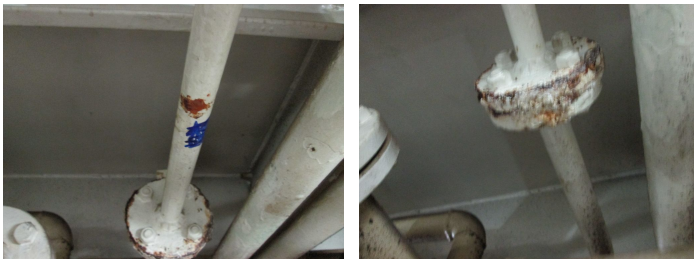
Sea water pipes seen with corrosion.	Renew areas of pipework that have evidence of corrosion or soft patches.	<\$1000

Corrective Action: Renew areas of pipework that have evidence of corrosion or soft patches.
