**CONDITION
REPORT**

EXAMPLE VESSEL

IMO Number: 123456789

**INSPECTED AT SINGAPORE
01st October 2022**

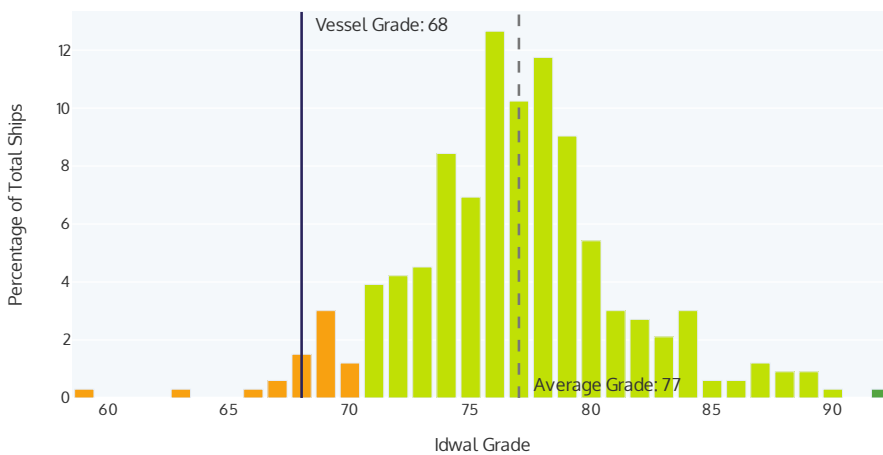
Your Idwal Grade vs other Capesize Bulk Carrier vessels

This graph shows the distribution of Idwal Grades against your ship's sector.
