PRE-SALE
REPORT

EXAMPLE GENERAL CARGO

IMO Number: 12345678

INSPECTED AT PLOCE CROATIA
OCTOBER 2022

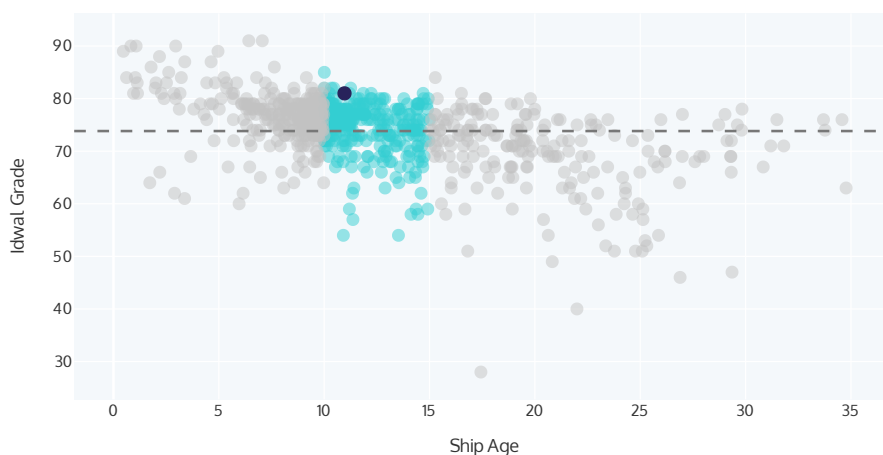
Your Idwal Grade vs other General Cargo vessels, age 10-15 years

This graph shows your ship's Idwal Grade compared against other ships inspected in the same sector, within a similar age range, and how it compares against the average Idwal Grade for the sector.
