PRE-SALE  
REPORT

# Example Tanker

IMO Number: 123456789

INSPECTED AT NEW YORK UNITED STATES  
01<sup>st</sup> OCTOBER 2022

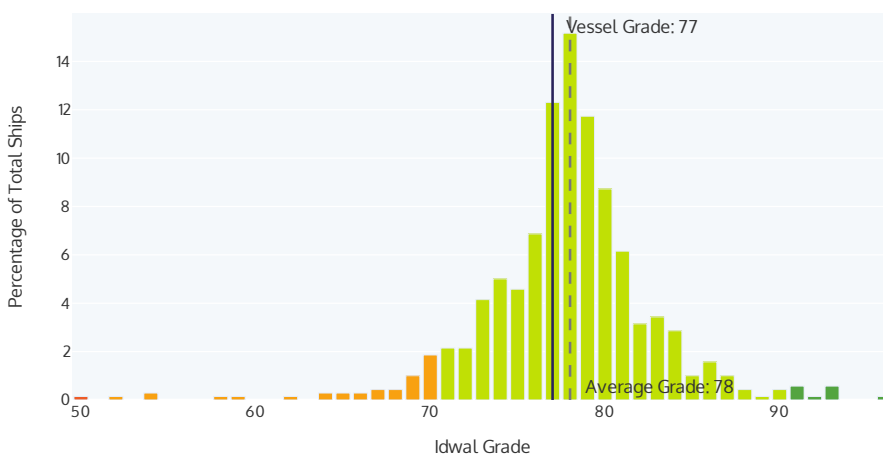
**Your Idwal Grade vs other MR Tanker vessels**

This graph shows the distribution of Idwal Grades against your ship's sector.

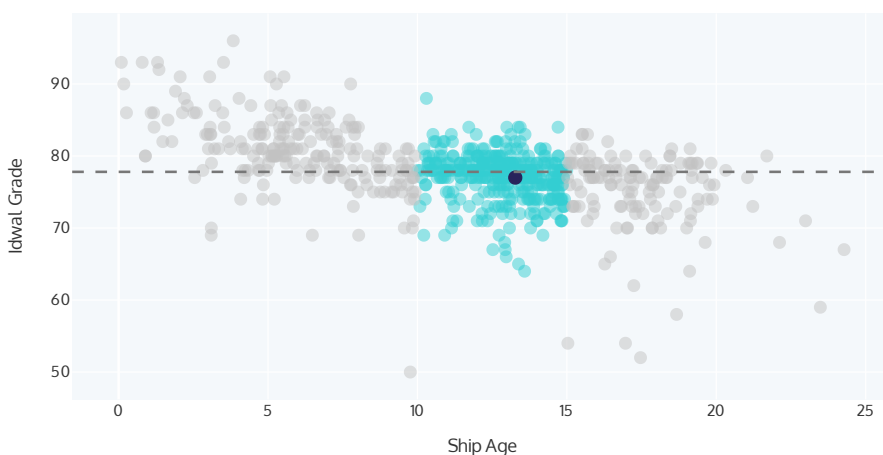
**Your Idwal Grade vs other MR Tanker vessels, age 10-15 years**

This graph shows your ship's Idwal Grade compared against other ships inspected in the same sector, within a similar age range, and how it compares against the average Idwal Grade for the sector.
