**PRE-SALE
REPORT**

EXAMPLE LPG VESSEL

IMO Number: 123456789

INSPECTED AT EXAMPLE PORT TRINIDAD & TOBAGO
1st - 2nd OCTOBER 2022

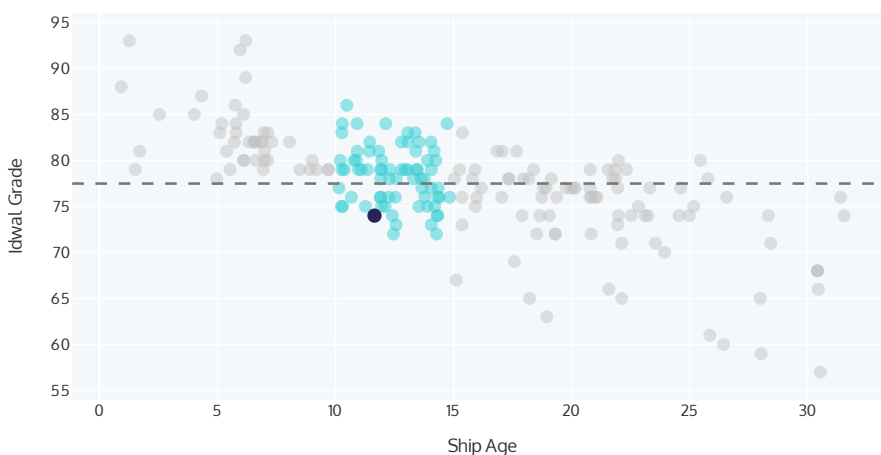
Your Idwal Grade vs other LPG Tanker vessels, age 10-15 years

This graph shows your ship's Idwal Grade compared against other ships inspected in the same sector, within a similar age range, and how it compares against the average Idwal Grade for the sector.
