PRE-PURCHASE
INSPECTION

Example Containership

IMO Number: 123456789

INSPECTED IN AUSTRALIA
1st OCTOBER 2022

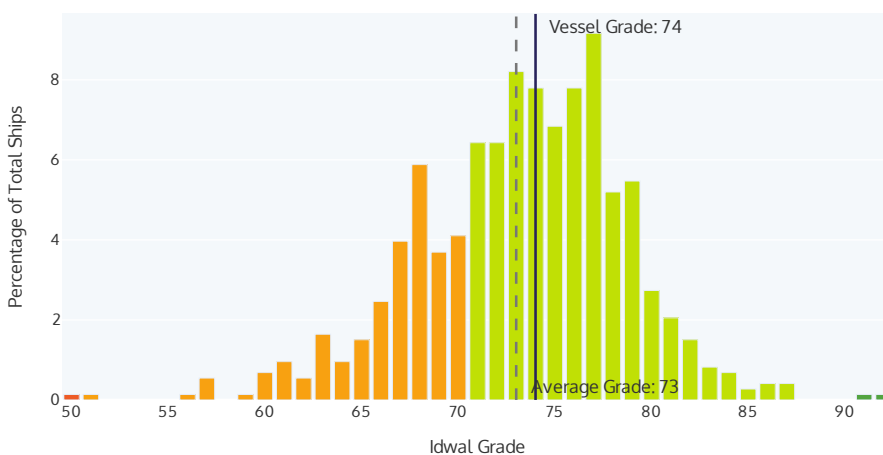
Your Idwal Grade vs other Feeder Container vessels

This graph shows the distribution of Idwal Grades against your ship's sector.
